Address: 7 Lafayette Street
Approximate/Documented Date of Building: 1849
Surveyed: 10/11/ 2019
Historic Name: Henry Rowe House
Classification: Individually-Designated Landmark

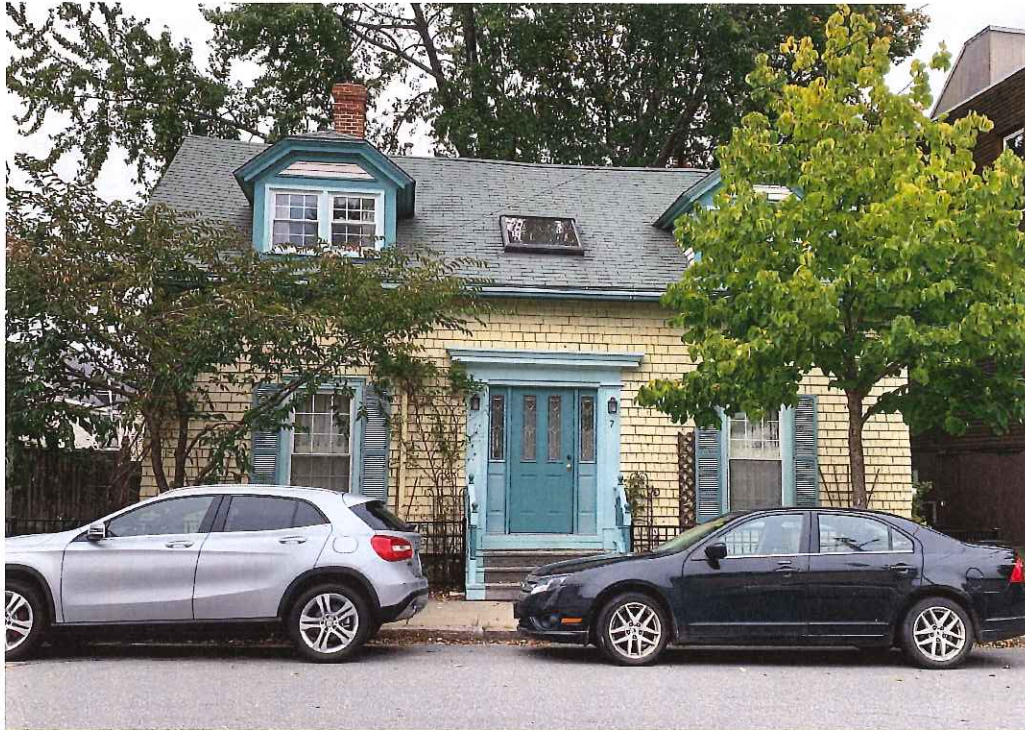
7 Lafayette Street is an excellent example of a one-and-a-half-story side-gable cape built in the mid-nineteenth century. It is one of the few buildings that has survived from the early settlement of Munjoy Hill. The dwelling boasts several distinctive elements, including a Greek Revival door surround and jerkinhead dormer windows over the façade. Though the building has retained some alterations in its 170 years, it has retained a high level of period detail. The three-by-two-bay dwelling has cedar shingle siding and replacement 6/6 double hung sash windows.

The façade is symmetrical, with the main entry in the center bay. The replacement single entry door is flanked by sidelights over panels and sits within a prominent Greek Revival surround. The two jerkinhead dormers over the façade each boast a pair of 6/6 sash windows with wooden trim. Unlike the rest of the dwelling's exterior, the dormers have wood clapboard siding. A skylight, which has been present since at least 1924, sits between the two dormers.

The eastern elevation features a projecting bay where a vestibule secondary entrance and window once stood. The asphalt roof exhibits a single brick chimney over the peak behind the western dormer. A shed dormer on the rear roof is not visible from the road.

7 Lafayette Street has retained several features or been restored to match the 1924 historical record in many ways. The main entry surround, dormer windows, and overall form of the house reflect its nineteenth-century origins. Deviations from historical record include the dwelling's current cedar shingle siding, loss of corner boards, loss of a second chimney, and removal of the window and entrance on the eastern elevation's first floor. The dormers once exhibited 4/4 windows, and the original main entry door originally featured a single light over panels, rather than two vertical lights. The current owners of 7 Lafayette have made significant efforts to restore architectural elements of the house to match its original form and retain its earlier character.
